P-1160, Project II Report

## **Nature-Based Solutions & Engineered Infrastructure for Risk Reduction in Coastal Areas**

**A Case Study in Corinto, Nicaragua**

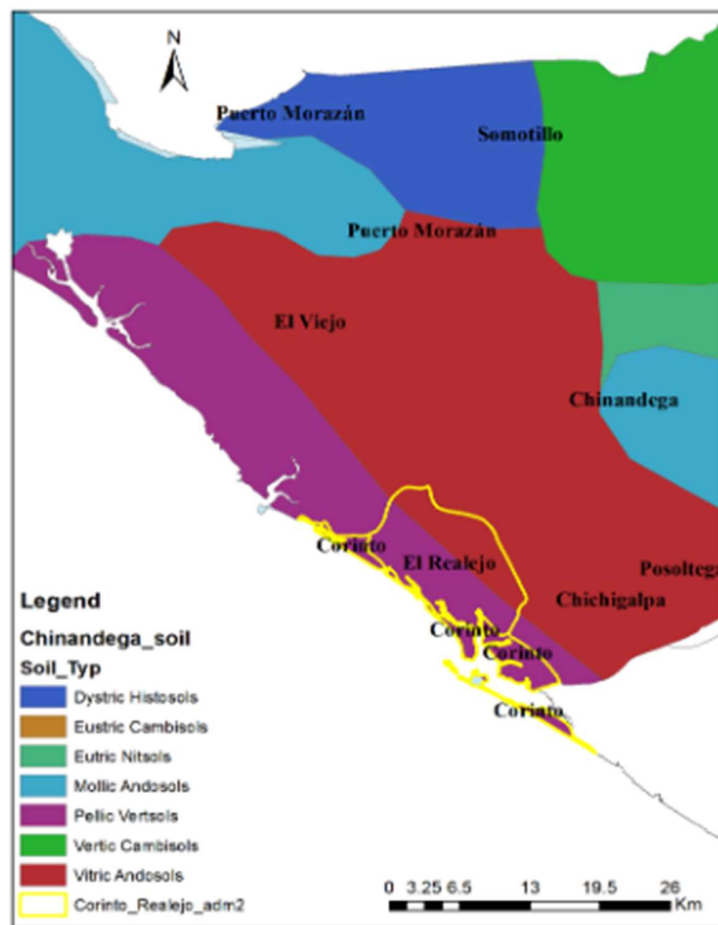
There are two types of soil dominantly found in Corinto: Vertisols and Andisols. As shown in Figure 8, coastal area including the port area is dominated by Vertisol soil type while inland consist of Andisol soil type.

Figure 8-Soil Distribution in Corinto and Al Realejo (FAO, 2006)

The local name used for Vertisols in Nicaragua is 'Sonsosuite'. Vertisols are characterized by clayey soil which shrinks when dry and swell when moistened and therefore wide cracks can often be sighted. Soil moisture regimes in Vertisol can vary with ustic, aridic, udic and xeric and soil temperature regimes that are cryic and warmer. Once the soil is thoroughly wetted and the cracks are closed the rate of water infiltration becomes almost zero (USDA NRCS, 1999). Corinto Port is classified as a sandy coast, the beaches consist of sand deposited by the tide and silty clay soil in low lying coastal areas. Between January

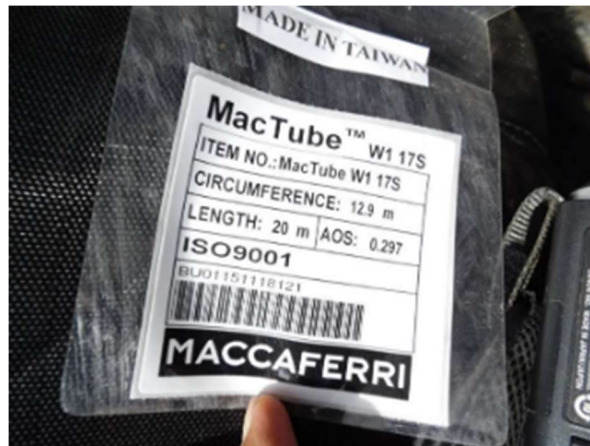
Maccaferri MacTube® in Figure 13aa was developed for coastal protection and is used for sea protection, dune reconstruction, breakwaters and groynes. This was the material used for geotubes installed in Corinto. The MacTube® W1 17S, manufactured with a special protective woven coast geo-textile with a polypropylene fibers, characterized by having a high mechanical resistance, that can resist high biological degradation and UV rays (Maccaferri, 2019). The final project consists of six breakwater structures with an average high of 1.5m, a length between 125 m to 200 m each, the volume used for each geotube is 16,000 m<sup>3</sup> of sand, obtained from ocean banks as shown in Figure 13 b and was placed along the coast line as shown in Figure 13 c (Axisima, 2016).

Figure 13a-Geotubes technical sheet (Vision Corintea, 2015)

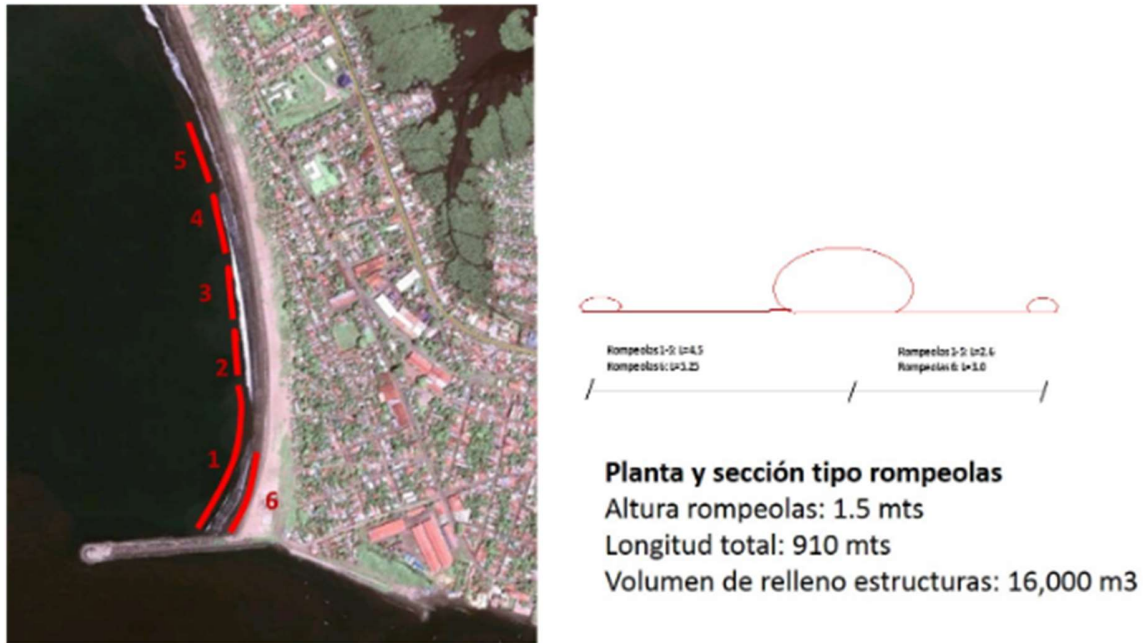
Figure 13 c-Geotubes location and technical data (Axisima, 2016)

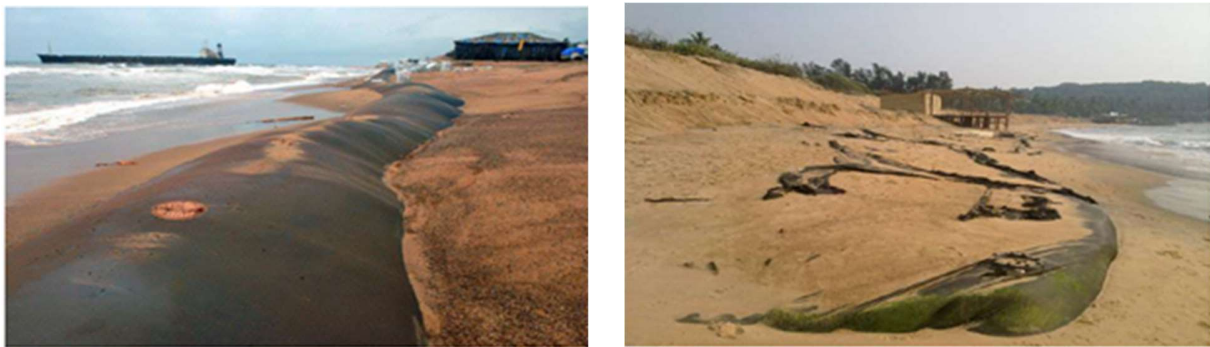
In geotubes implementation project, is important to take some factors in consideration that might create problems in the future like the tidal variation, the wave strength variation and degradation of the geotubes by ultraviolet sun radiation. The tidal variations and wave power could cause failure of the geotubes if not considered during the design and selection of the geotubes to be installed. Such a case was at Condolim beach in India, they noticed that there was a tidal difference of 2.53 m between high and low tide along with variation on wave strength which lead to the damage of the geotubes, as a result the filling came outside, as shown in Figure 16. A change in the design was required. The new design was to use one tube above the other with additional protection using riprap (R Parab *et al.*, 2019).

Figure 16-failure of Geotubes at Candolim beach in India (R Parab *et al.*, 2019).

At areas with high wave actions there a high chance of abrasion to the geotubes which required the used of material with high tensile strength and/or multi-layer tubes. In areas with high ultraviolet sun radiation, there is a higher degradation to the outer layer of the geotubes which required a resistance layer of carbon black coating to lessen this effect (Lee *et al.*, 2014).

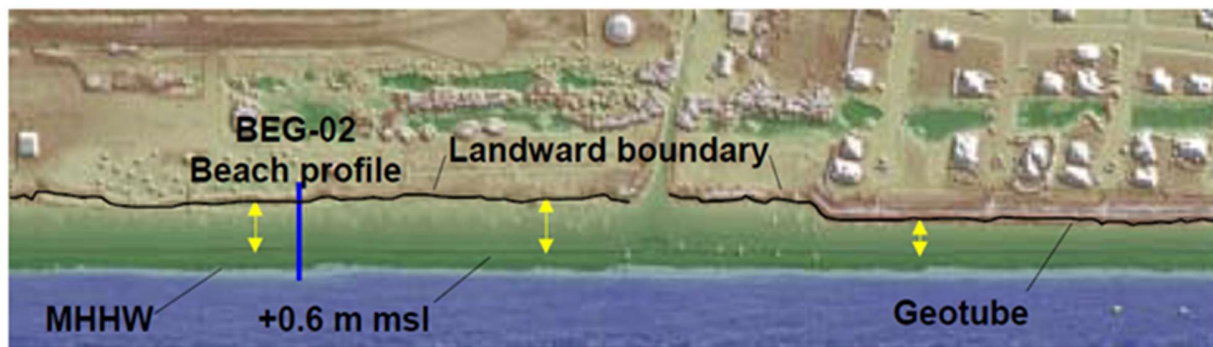
- d. A topographic airborne survey can be done, to the area where geotubes are located and the adjacent areas to check the width of the beach, as shown in Figure 17. Normally the area in front of the tubes is narrower compared to neighboring areas where geotubes are not applied, due to the movement of the sediments towards the tubes and other areas of the beach (Gibeaut *et al.*, 2003).

Figure 17-Image of the southwest end of the Pirates Beach geotube project and the northeast end of Galveston Island State Park along the gulf of Mexico, arrows represent the beach's width (Gibeaut *et al.*, 2003)
